**CWA COMPLIANCE EVALUATION INSPECTION REPORT
U.S. ENVIRONMENTAL PROTECTION AGENCY, REGION 5**

Purpose: Compliance Evaluation Inspection

Facility:
Ex. 6 (Personal Privacy) Winding Acres Farm
Ex. 6 (Personal Privacy)
Ex. 6 (Personal Privacy) Stephenson County
Ex. 6 (Personal Privacy)

Date of Inspection: September 24, 2020

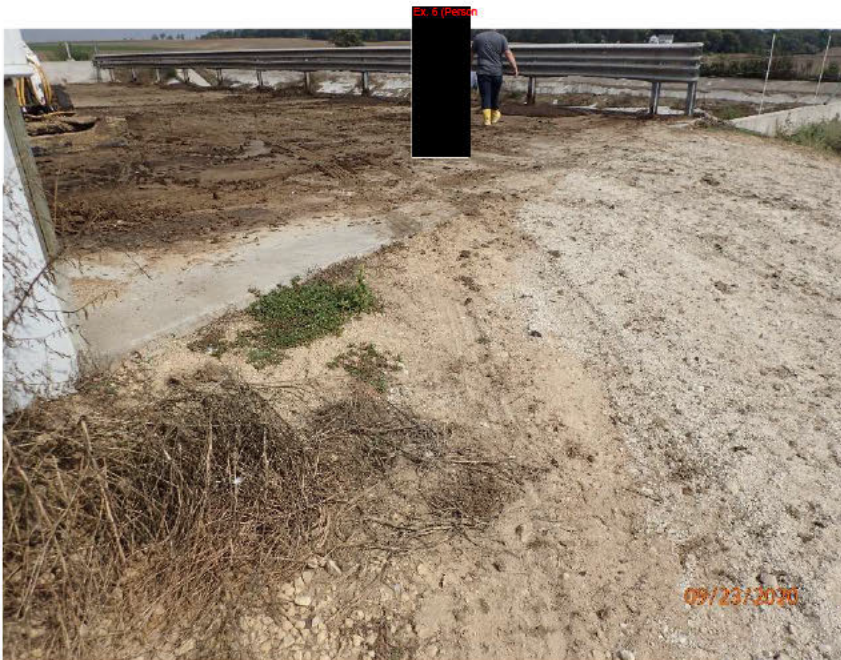
8: P9230008

Description: Manure pushout area on the east side of the Big Barn. Note the mountable curb to prevent runoff from leaving the area. Big Pit in the distance beyond the guardrail.

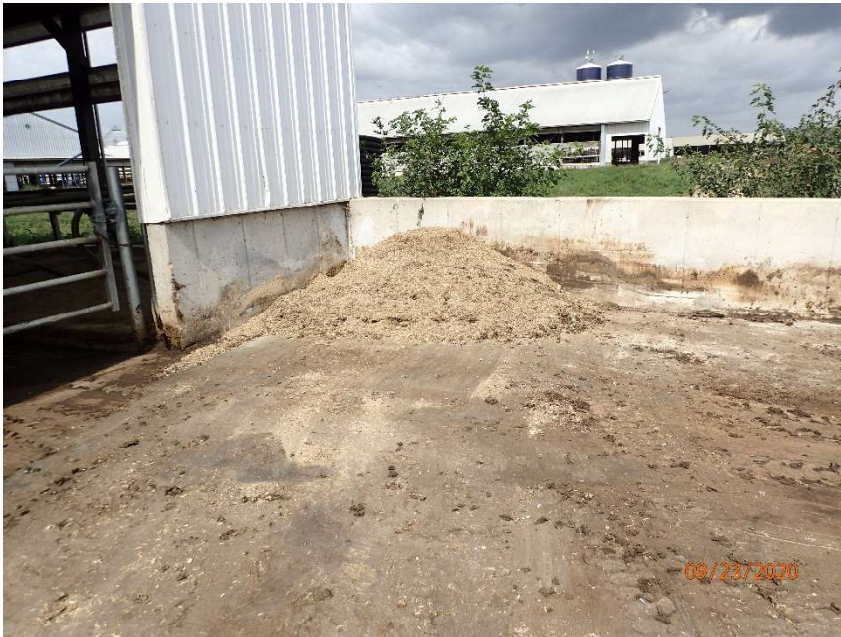
10: P9230010

Description: New mortality compost pile located in northwest corner of Big Barn manure pushout area.

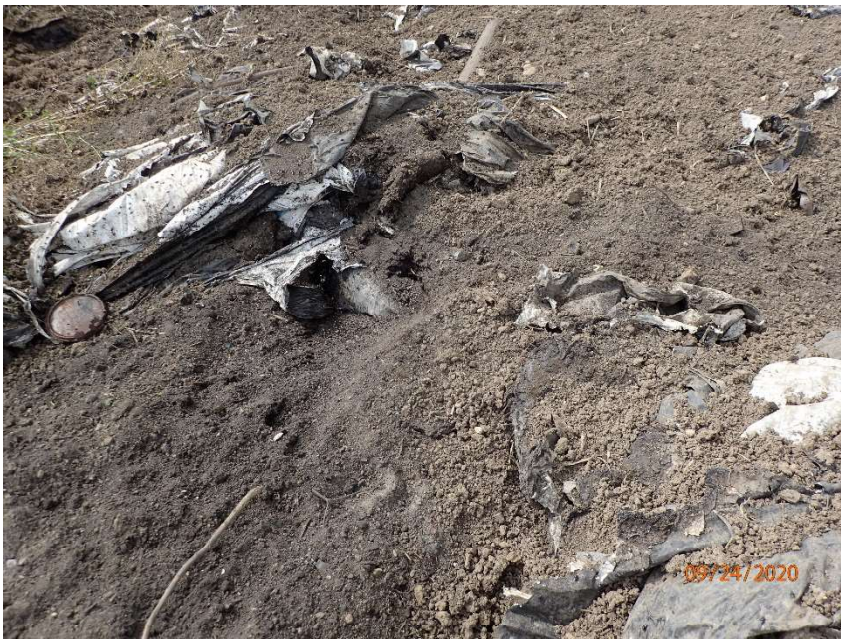
11: P9240011

1. Leachate from the North Silage Pad was observed leaving the pad.
2. Partially decomposed mortalities were observed in the filled area south of the Big Pit.
3. The Little Pit had a leak in the northeast corner.

Description: Recently filled area south of the Big Pit. Note presence of waste plastic silage bags and there was an exposed partially composted mortality.

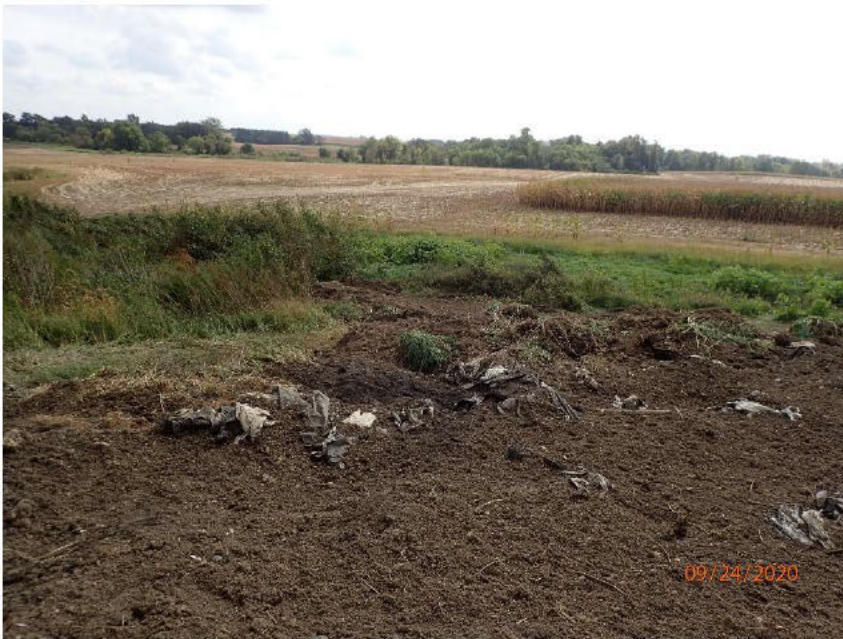
12: P9240012

Description: Recently filled area south of the Big Pit. Note presence of waste plastic silage bags and there was an exposed partially composted mortality.

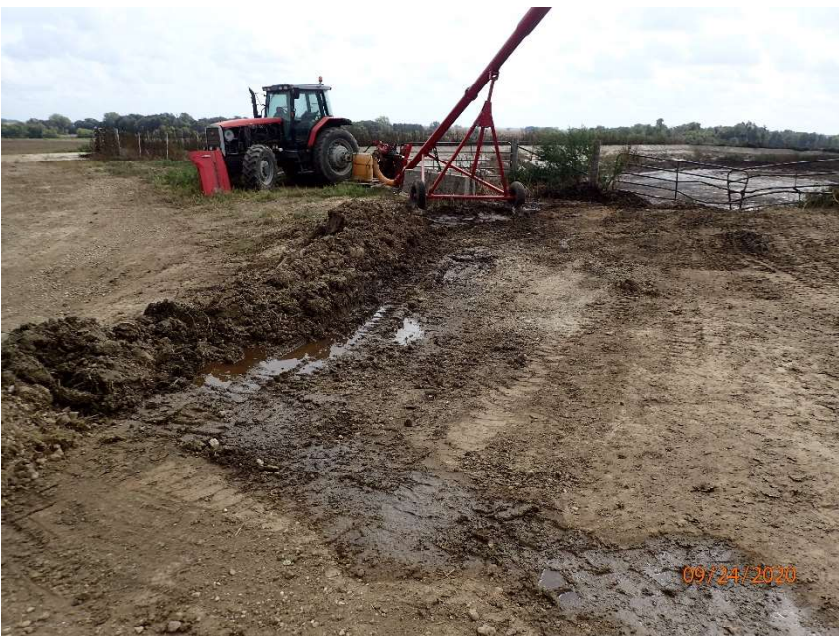
15: P9240015

Description: Berm built to contain and direct leak from the Little Pit to the Big Pit.

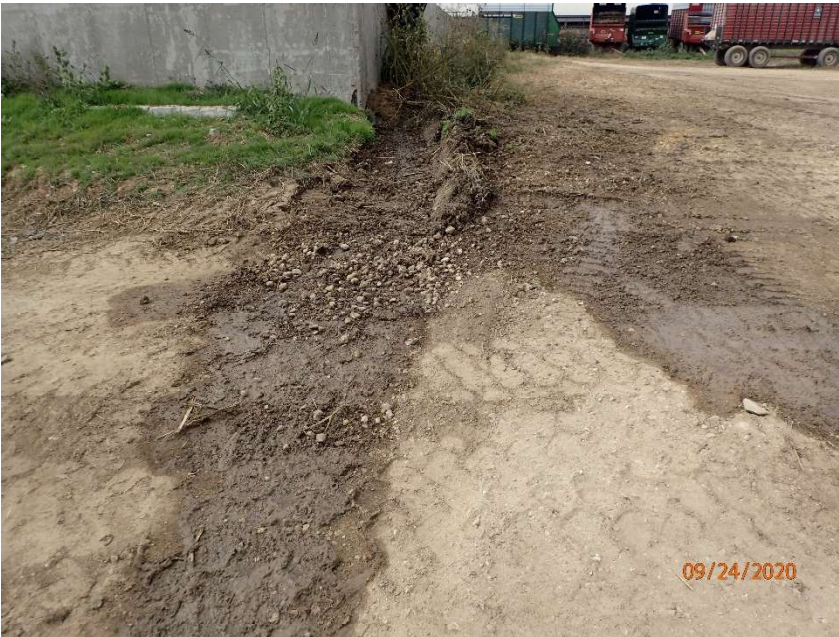
16: P9240016

Description: Leak from the Little Pit.

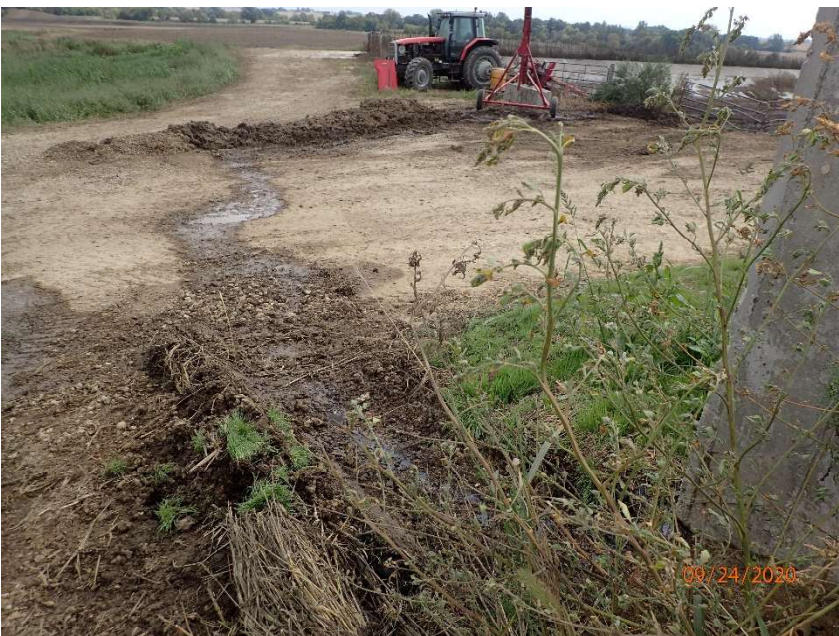
17: P9240017

Description: Flow path of leak from the Little Pit along the berm toward the Big Pit.

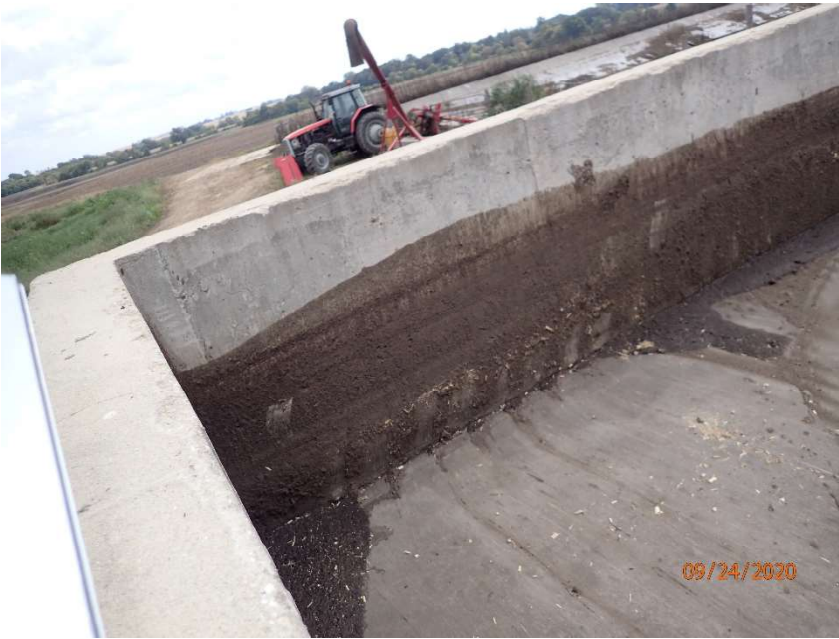
18: P9240018

Description: View of the interior of the northeast corner of the Little Pit.

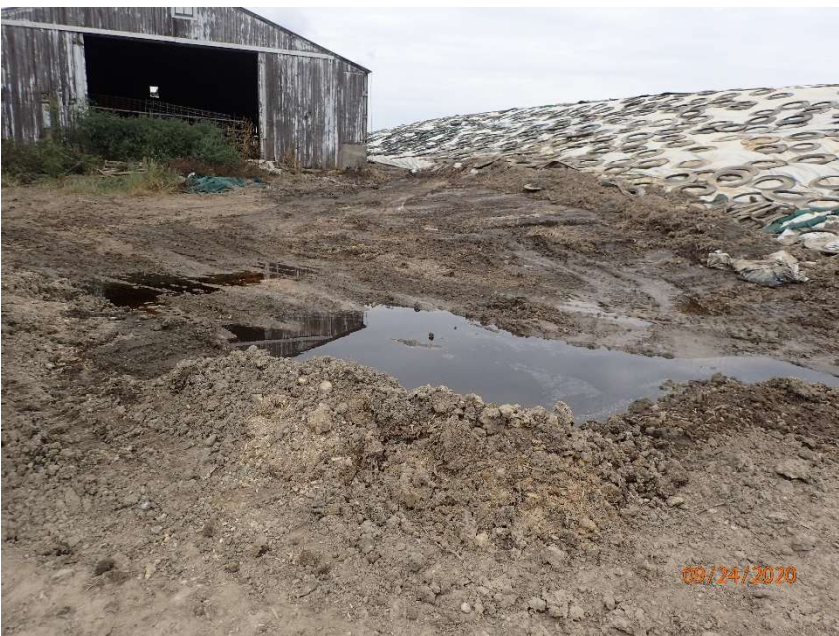
25: P9240025

The Inspectors continued North and observed the Beef Barn (photo 24) and then observed, between the Beef Barn and the Steer Lot, silage leachate that appeared to have leaked from the North Silage Pad (photo 25). It appeared that the Operator had formed berms to collect the leachate. The Operator stated that due to unusually wet silage he had been collecting and scraping the leachate daily. He stated that this was the first year they had encountered that problem and intended to return to putting up their silage drier the following year.

Description: Silage leachate from the North Silage Pad being collected behind a berm between the Beef Barn and the Steer Lot.

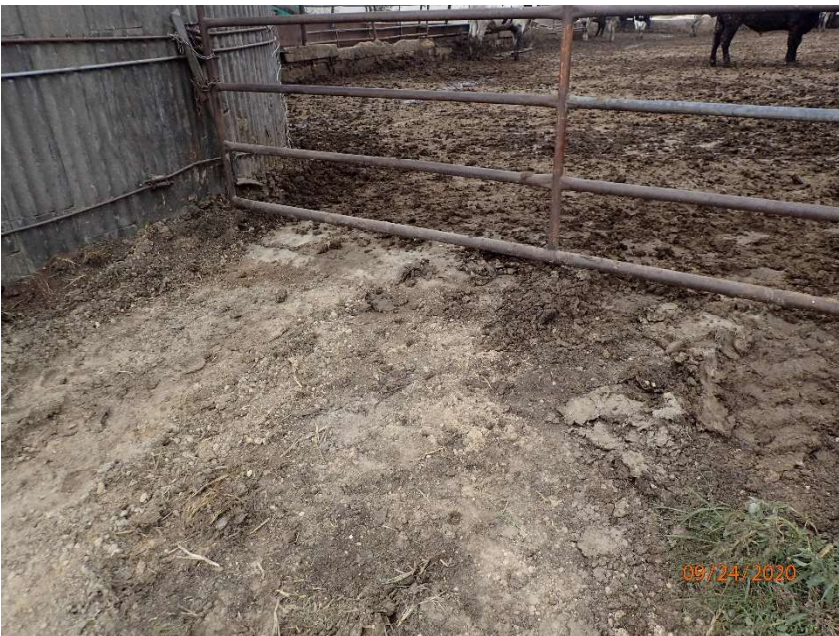
27: P9240027

Description: Closer look at the gate on the east side of the Steer Lot. The Operator stated the lot was sloped so that all manure and process wastewater runoff from the lot would be collected into the pit under the Old Dairy Barn. Raised concrete below the gate prevented manure and process wastewater from flowing to the east.

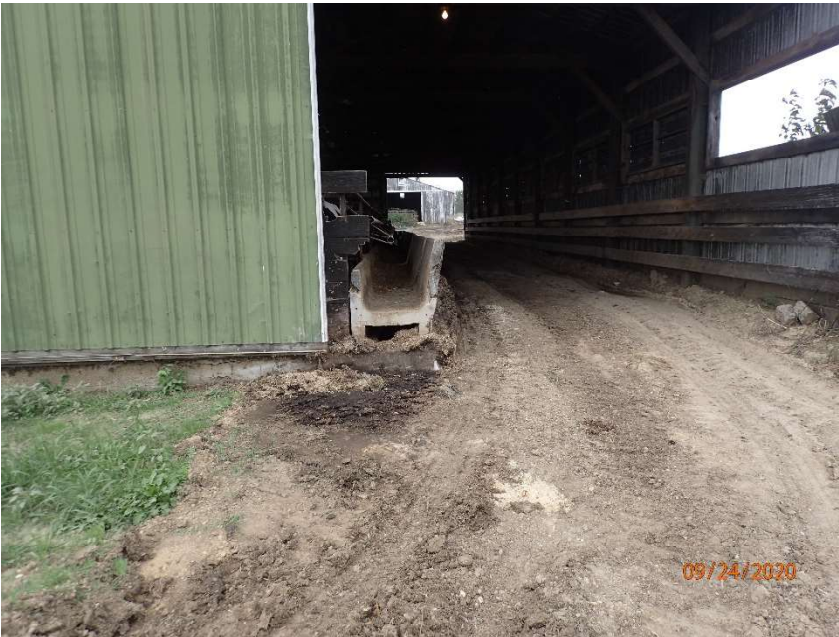
34: P9240034

The Inspectors then walked back east and north past the east end of the Beef Barn. The Inspectors noted to the Operator that the open end of the feed trough allowed any runoff

from the feed trough to flow out of the building (photo 34). The Operator stated that he could cover the end of the trough to ensure that nothing flowed out of the building.

Description: Looking into the east end of the Beef Barn. Feed trough does not have containment on the end and feed and process wastewater can leave the trough.

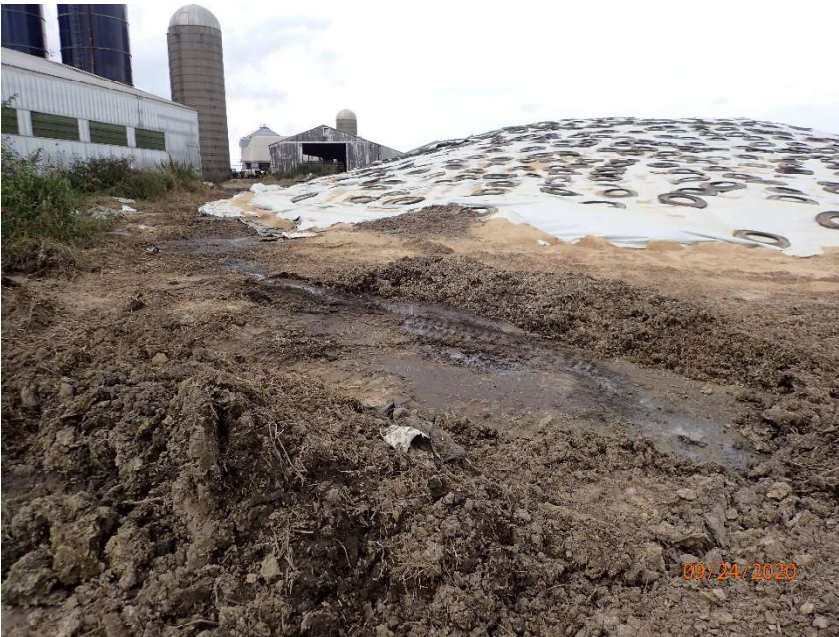
35: P9240035

The Inspectors walked north pasted the east end of the North Silage Pad and observed further leachate and collection berms (photos 35 and 36). The Inspectors informed the Operator that the leachate is considered process wastewater and that he should ensure that it did not discharge to a waterway. The Operator stated that he thought he could build a double berm to ensure that no leachate left the site until they could use the feed on the silage pad.

Description: Looking west at the east end of the North Silage Pad. Note the silage leachate being collected by the berm.

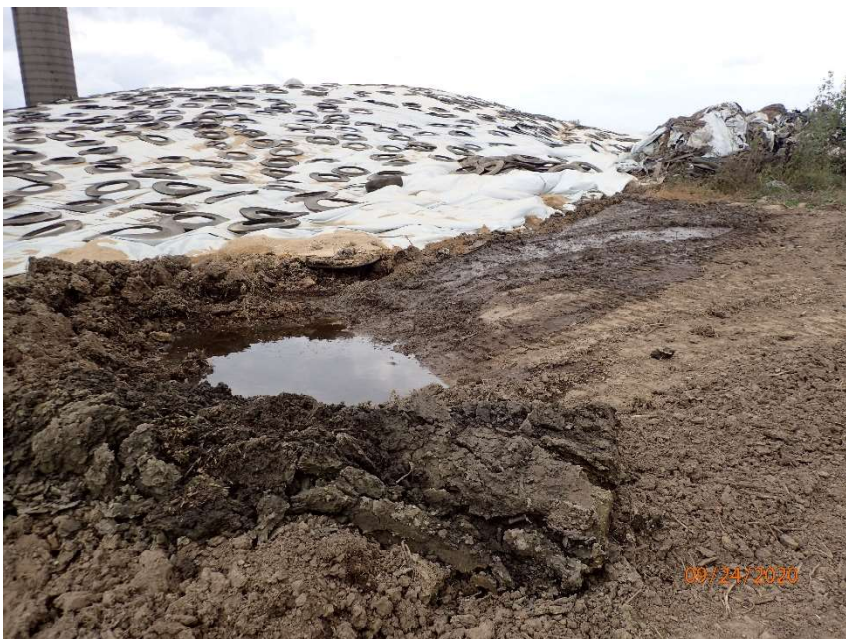
36: P9240036

Description: Looking west at the east end of the North Silage Pad. Note the silage leachate being collected by the berm.
